NATIONAL SOILS CONFERENCE

Conference Tour, Wednesday 21 November, 2018

Urban Soils

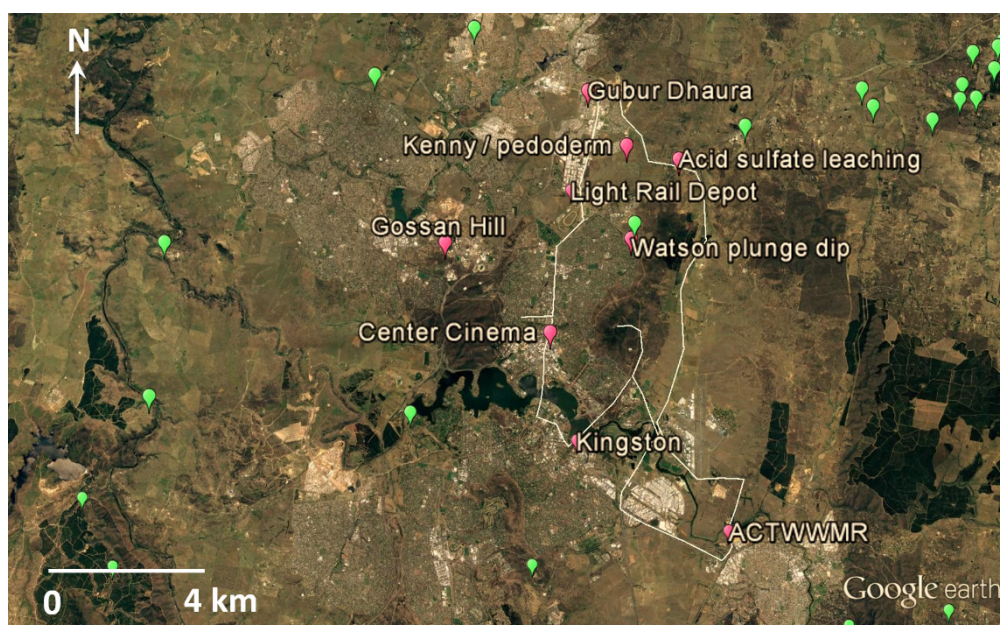
Figure 1. Features of the Urban Soils Field Trip. Green icons indicate metal deposits / mines, pink indicate other features discussed on the field trip

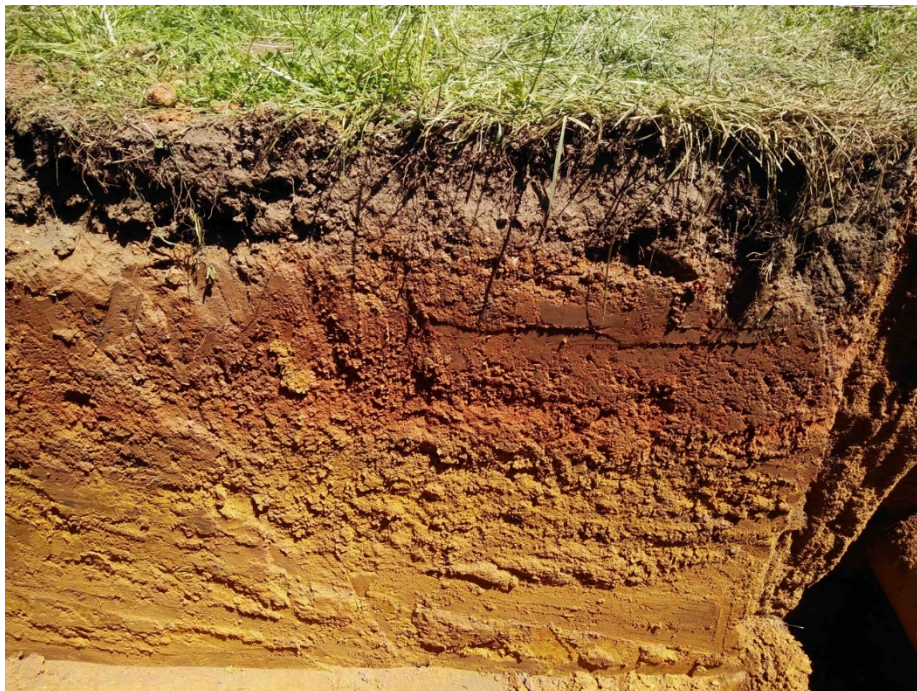
Figure 2. One of the first test pits inspected with better quality topsoil

SESL's involvement in the project began with a detailed soil survey along the rail corridor to determine the quality of the available site soil as a reusable resource and its suitability for landscape development. We inspected more than 50 locations along the corridor from 2015 to 2017, and ran a series of chemical and physical analyses on multiple samples of the topsoil and subsoil (nutrients, cation exchange, particle size grading, hydraulic conductivity etc.) from a large number of sites along the rail corridor (Figure 2, Figure 3, Figure 4).

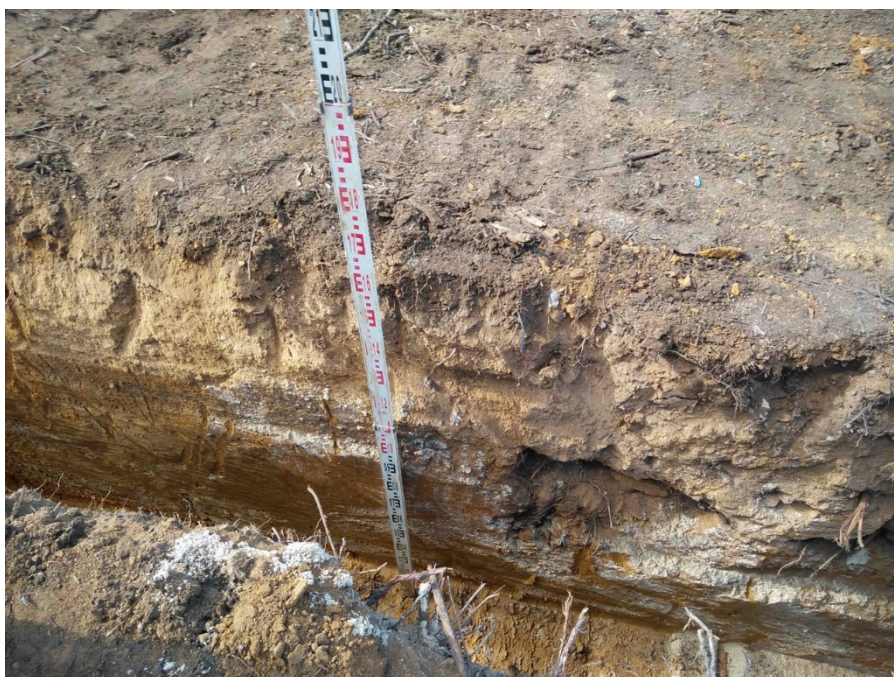
Figure 3. This trench had residual backfill sand material, common along the corridor where existing services are within vicinity

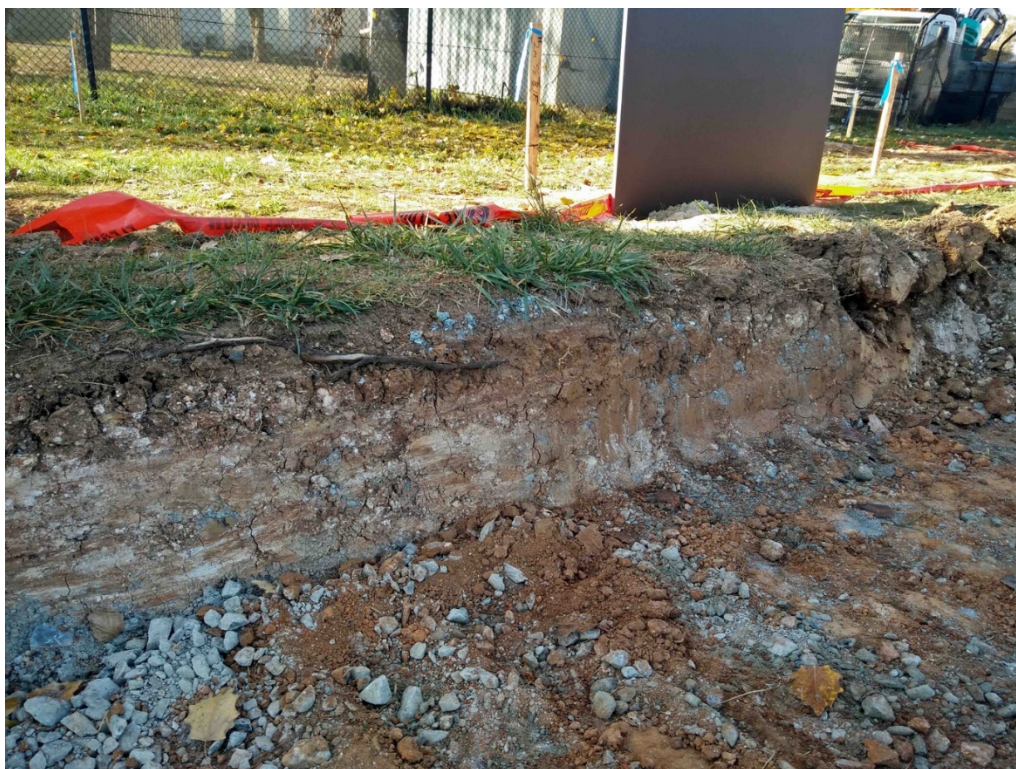
Figure 4. This was a road verge with fill material, hardly any suitable site soil resource for reuse

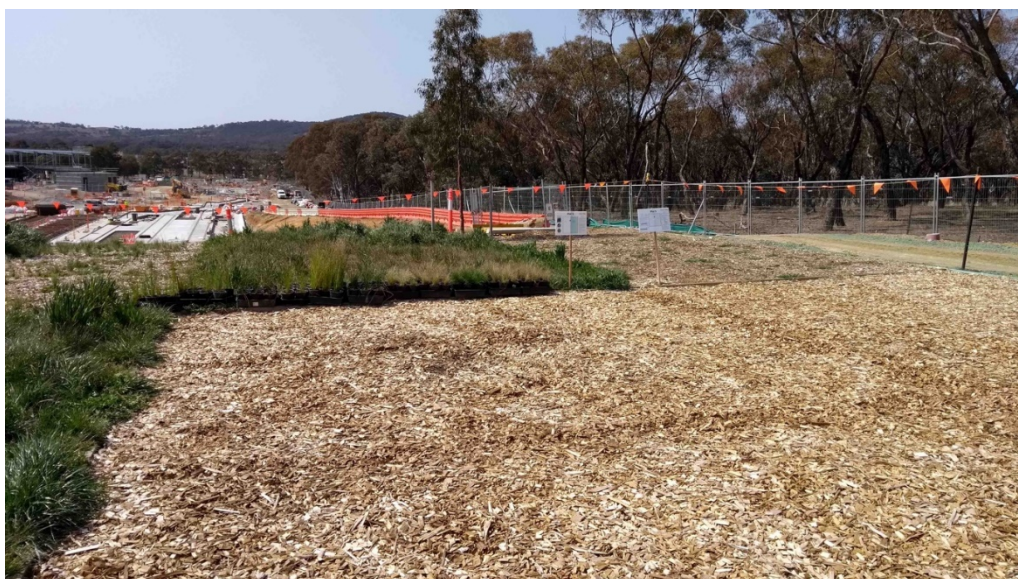
Figure 5. Start of the trial plot – September 2017

SESL also assisted in trials of the specifically designed soil using the proposed landscape plantings. These trials were conducted at specific trial plots located at the light rail depot and are now a permanent feature of the project (Figure 5).

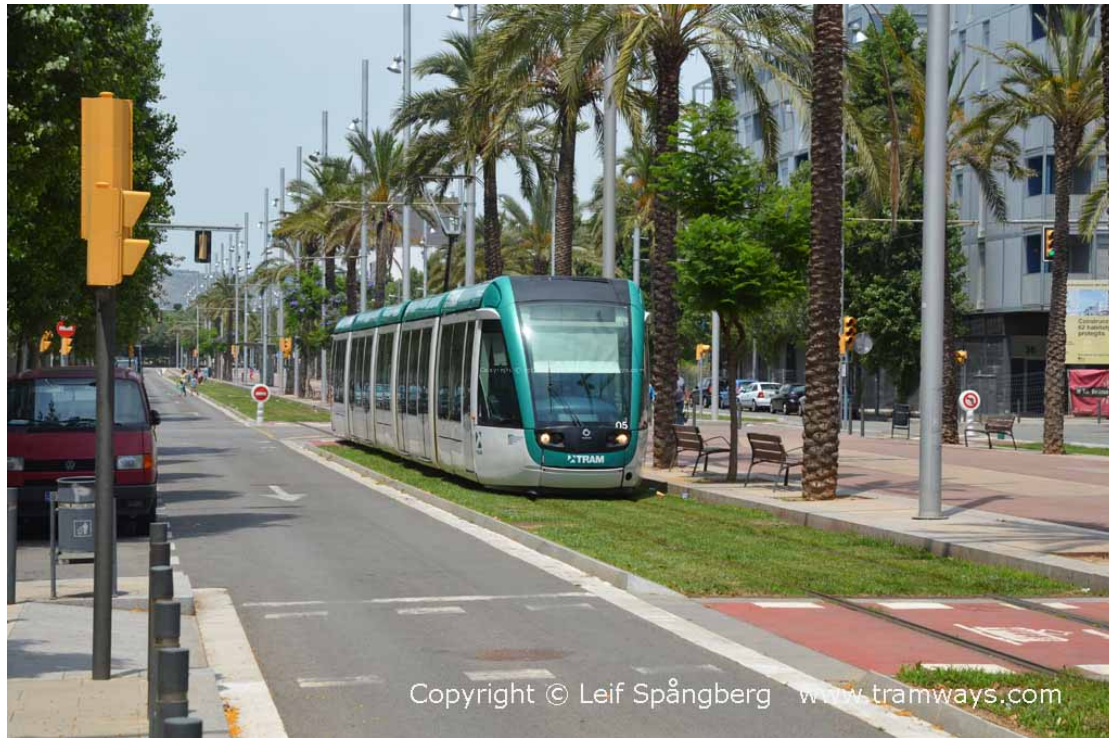
Figure 6. This is a photo of a light rail system (tram) in Barcelona. Look at the tree plantings in limited space and surrounding services!

Our assistance proved invaluable in designing soils for vaulted tree planting areas for advanced tree planting in locations with limited soil for root growth. Think about street trees in urban environments where no soil is visible, it's all paved (Figure 6)! How do we ensure the trees will grow and become well established over the next 20 years? Where do roots go? How are we going to irrigate or add fertiliser? This is a critical aspect for the project as these areas typically have the highest amount of pedestrian traffic and the trees in these areas supply important green infrastructure to all users.

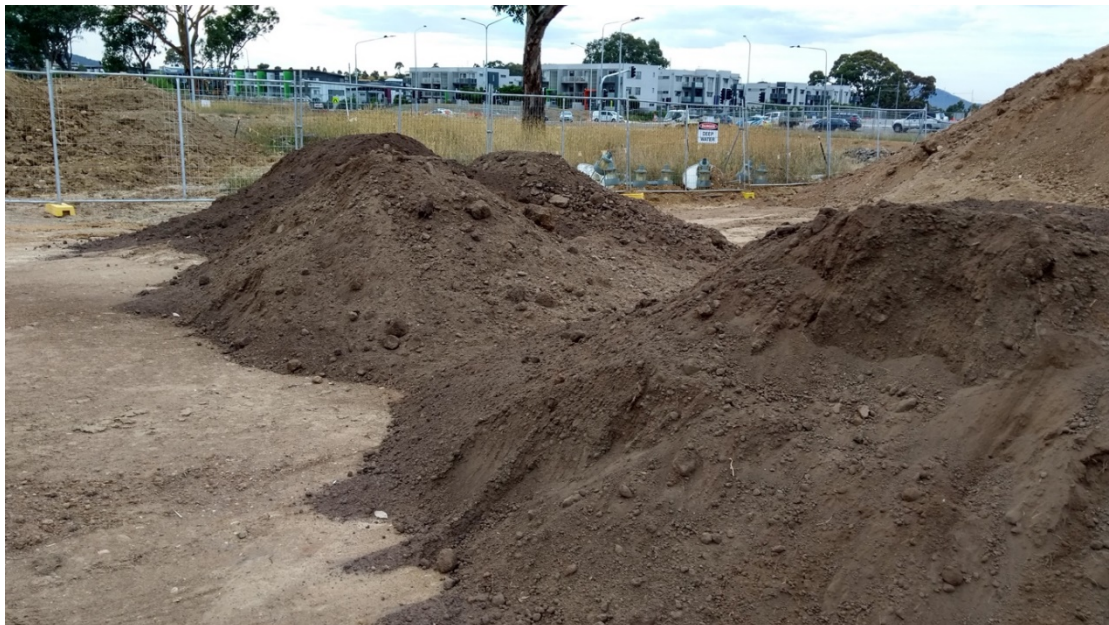
Figure 7. Some of the imported topsoil (better quality!)

Soil must possess specific characteristics and properties in order to provide a strong foundation for its intended use. SESL's science based approach determined the most appropriate soil characteristics and properties that would support optimal and sustained plant growth for the project, regardless of the challenges. This included, in the event of insufficient site topsoil, that imported topsoil was assessed and validated by SESL Soil Scientists to ensure it could support the landscape as required, and to prescribe any treatment necessary (Figure 7).

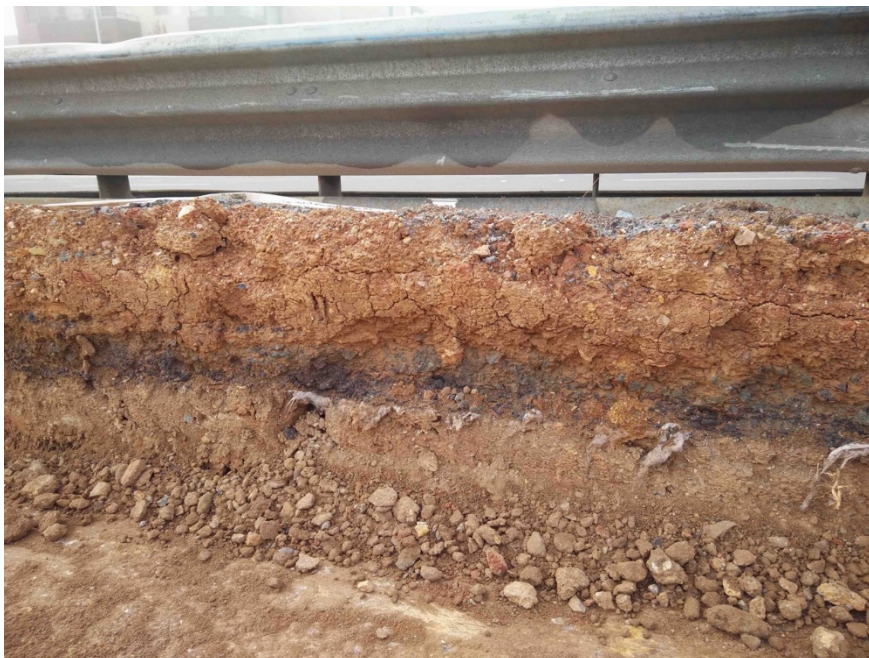
Figure 8. Imported fill with no topsoil under a slab in a part of the project area thereby limiting the soil resource available for reuse. A large portion of the project area where there was bulk earthworks was similar to this, hence limited available soil resource

Canberra soil is also typically infertile or has low fertility. Most development sites typically have very little topsoil and shallow rocky soil profiles (Figure 8 and Figure 9). Local topsoils are either acidic, or magnesian – this further contributes to low quality topsoil and requires treatment/amelioration to support plant growth. Magnesian subsoil also poses concerns from an erosion perspective as it has a weaker soil structure.

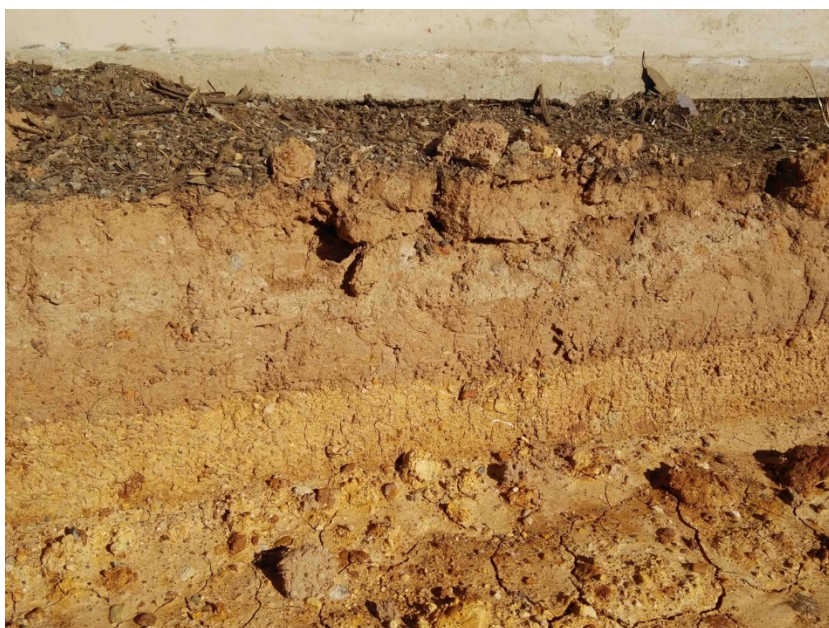
Figure 9. Where's the topsoil?

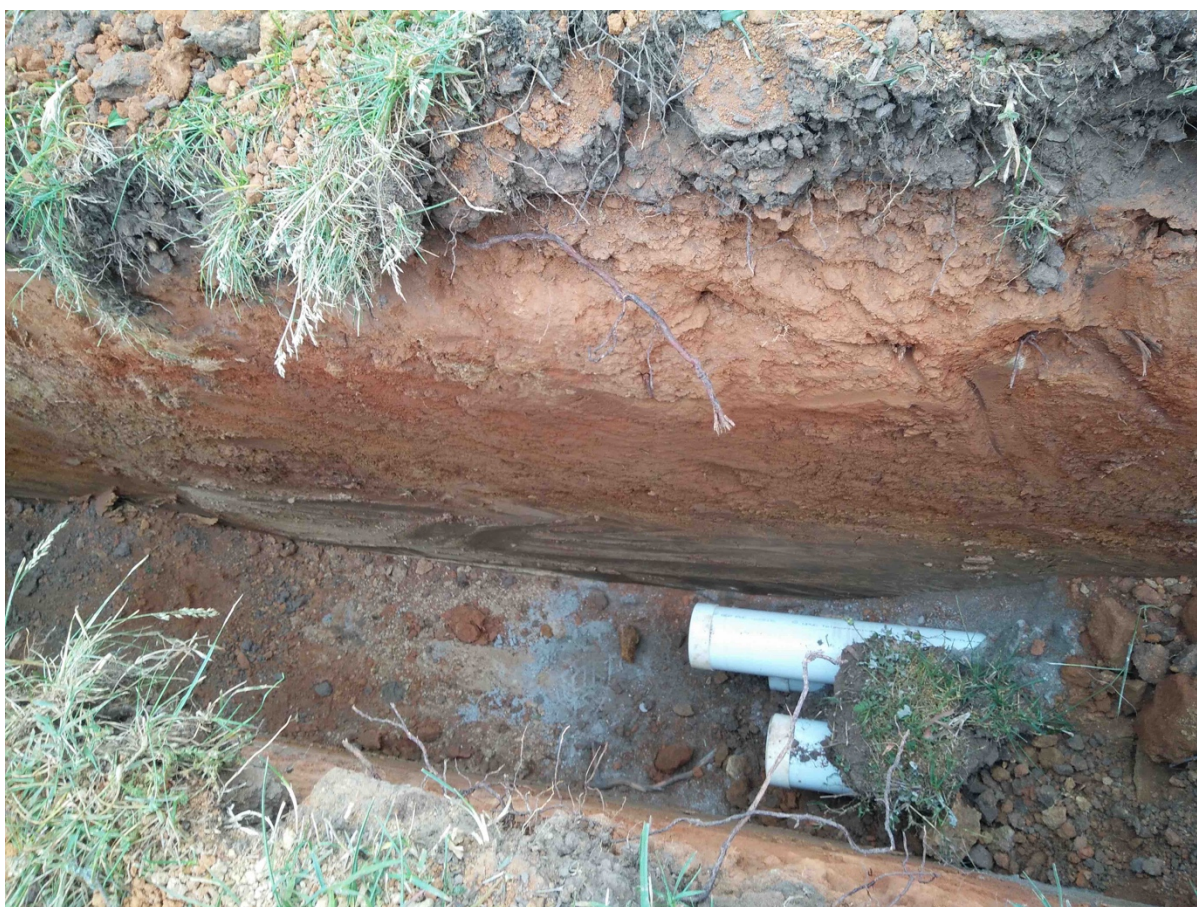
Figure 10. Trench with services and limited topsoil

Also, a large portion of the project area had very limited topsoil due existing infrastructure (Figure 10).

Additionally, project sites generally pose their own challenges such as soil compaction on planting sites from heavy construction vehicles. There can also be limited space in some areas to plant trees and to allow for sufficient root growth (root zone) due to the proximity of concrete slabs and/or the presence of large amount underground services in highly urbanised areas (i.e. light rail stops or city (Figure 10)).

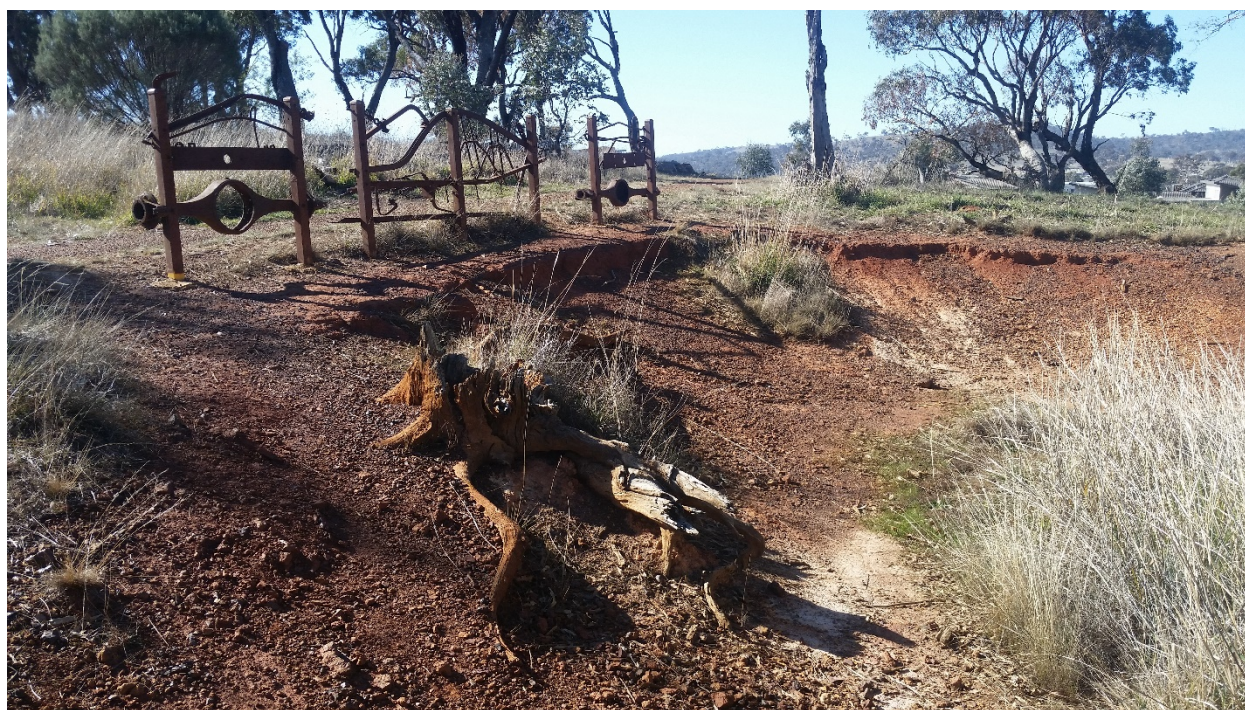
Figure 11. Historical artefacts at Gubur Dhaura, Franklin, surrounded by iron-rich soils and iron stone. Photo collected July 2018

Some sites and related soils in the Canberra region are naturally metal-rich and have been exploited by people for tens of thousands of years. Initially Canberra's indigenous peoples, the Ngunnawal, mined iron-rich gossans/ironstones for ochre, with evidence of such mining at Gubur Dhaura in Franklin (Figure 11). This site was also prospected for other metals by early European settlers, before being used as a source of kaolin (pipe clay)^{4,5}. It is today preserved as an historic and educational site.

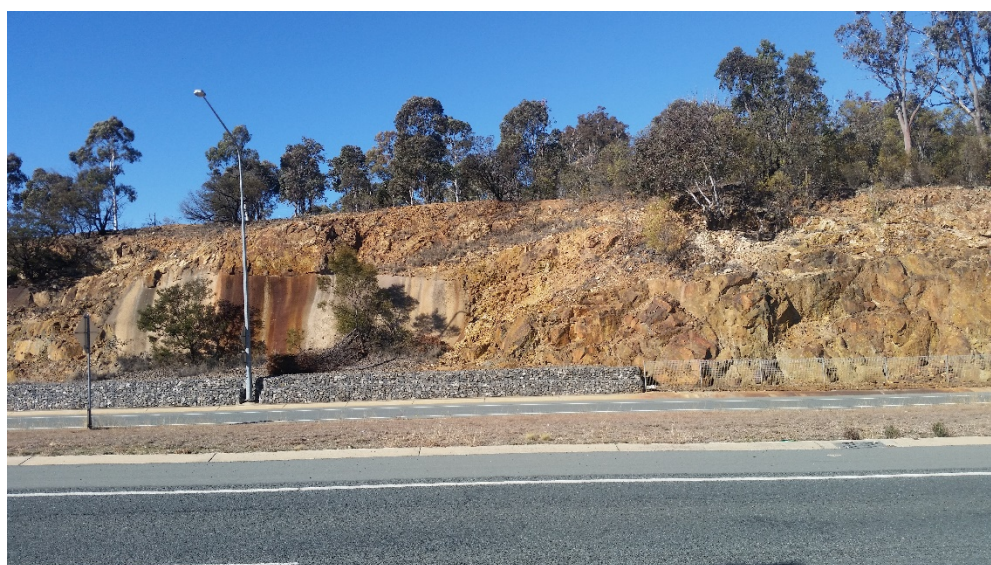
Figure 12. Metal-sulfide bearing Ainslie Volcanics near Mt Majura north of the Watson site which contains high concentrations of arsenic. Photo collected at the intersection of the Federal Highway and Majura Avenue, July 2018

or were backfilled (Figure 12). With little visual indication of their former presence. It is only when analyses of soil samples undertaken as part of routine contaminated lands assessment indicate metals/metalloid concentrations above guideline levels that there are indications one might be on an area of mineralisation. Arsenic, nickel, lead, manganese, beryllium, silver, zinc, and copper are all elements considered contaminants of concern, which can naturally occur in high concentrations, and potentially over the National Environment Protection (Assessment of Site Contamination) Measure 1999 guidelines⁷.

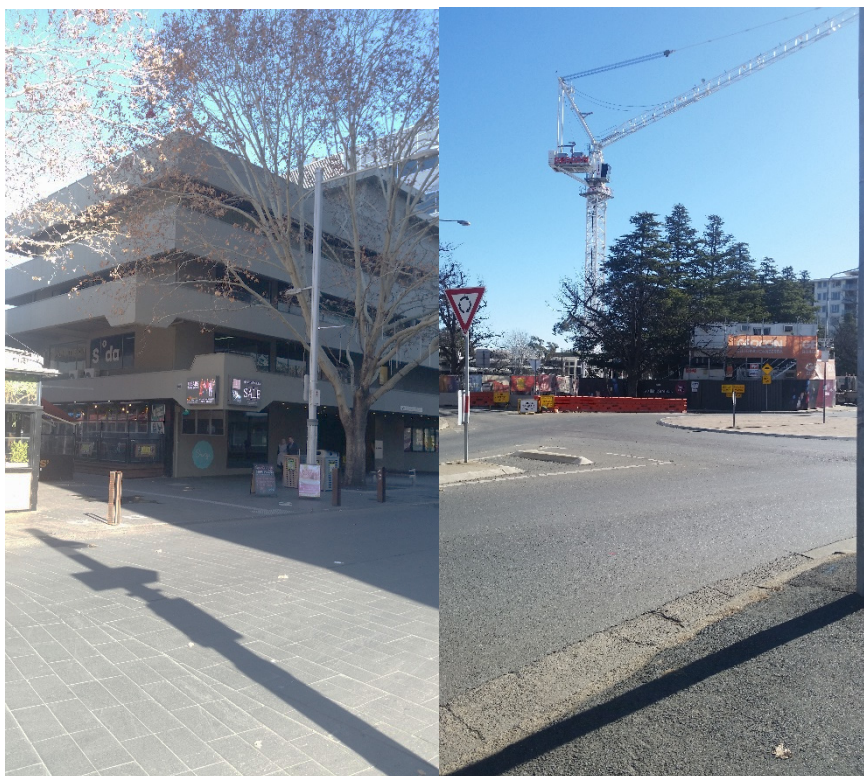
Figure 13. Shorty's, where the Center Cinema was once located (left). Building construction at the corner of Mort and Elouera Streets where the former NRMA building was once located (right). Photo collected July 2018

The Civic plume was the first reported petroleum contamination of groundwater in Australia. It was discovered as the result of a fatal explosion in February 1977 after petroleum vapours intruding into the Center Cinema were ignited when pipes were being welded^{13,3} (Figure 13). A plumber died and his assistant was injured in the explosion³. Fumes had been reported in the building since 1976 and petrol seeped into the building through the groundwater drainage system after periods of heavy rain. At the time, this building was located in the deepest excavation in Canberra and intercepted groundwater carrying the plume south from service stations in Braddon. There were twenty service stations and vehicle workshops with more than 60 underground petrol tanks in Braddon at the time³. The hydrogeological investigations initiated after the fatal Center Cinema explosion found that the plume was 4.5m deep in places, covered 5.3 ha, and contained 32 000L of petrol³.

A separate and unconnected plume was discovered at the NRMA building in Braddon (corners of Northbourne Avenue and Elouera Street) in 1978, nine years after it was built. It covered an area of about 300m² and contained 2000 L of petrol (Figure 13). It was considered this plume was caused by overfilling of an underground storage tank—due to this tank being free of leaks when excavated.

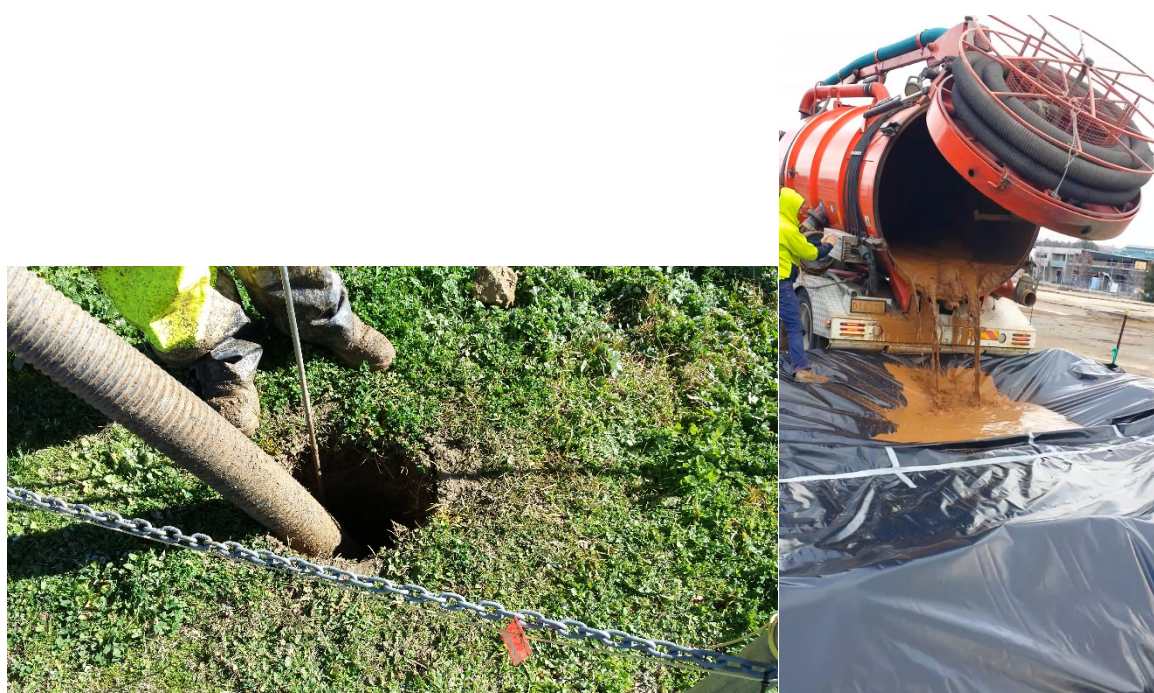
Figure 14. (Left) Non-destructive drilling (back-of-hole) and hydrovac (front-of-hole). (Right) Drillers mud being emptied from a hydrovac truck
